SIXTH FIVE-YEAR REVIEW REPORT FOR  
SOLID STATE CIRCUITS, INC. SUPERFUND SITE  
GREENE COUNTY, MISSOURI

Missouri Department of Natural Resources  
Environmental Remediation Program  
Jefferson City, Missouri

U.S. Environmental Protection Agency  
Region VII  
Lenexa, Kansas

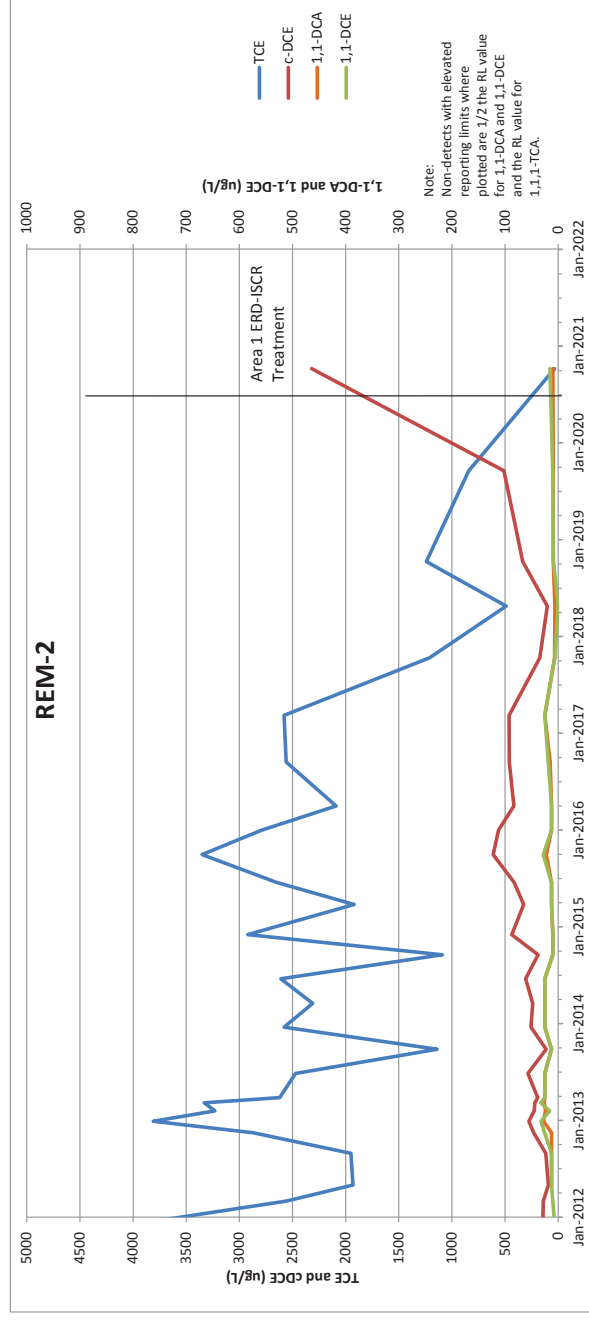
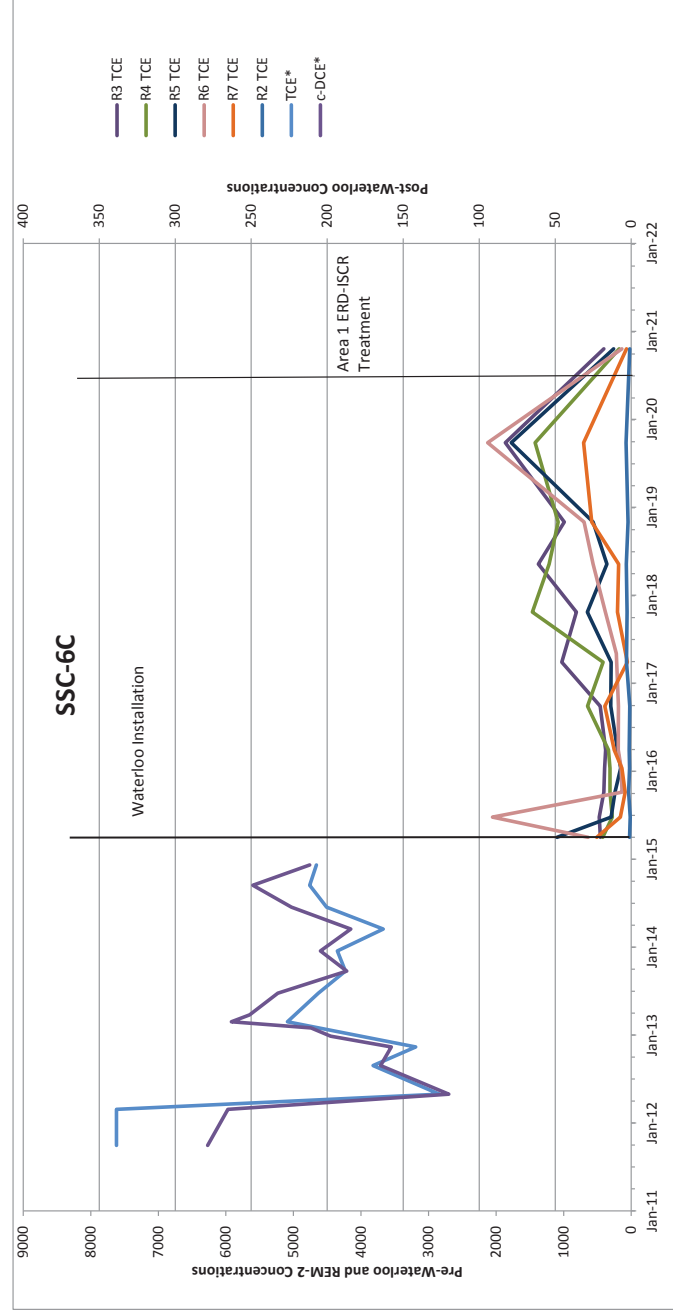
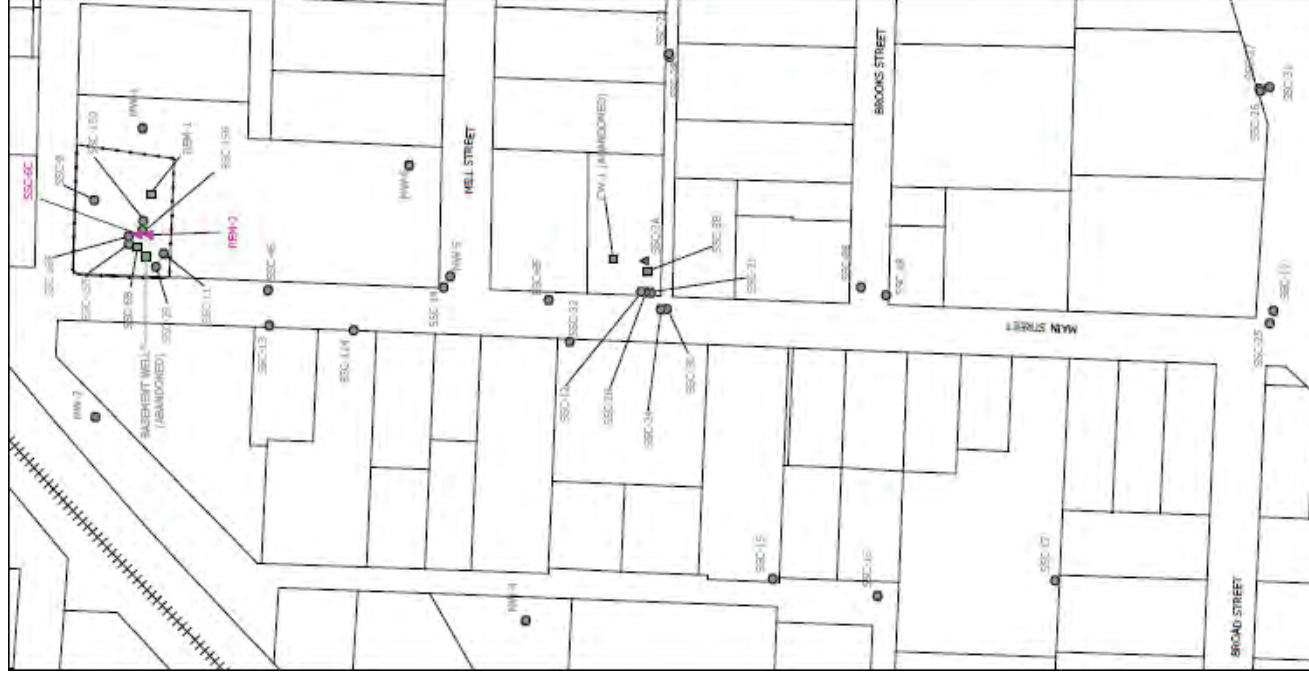
**FIGURE 42**

TCE concentrations at REM-2 (Figure 42) have generally been near 2,000 to 3,000 µg/L since the 2011 fire, prior to decreasing to 33.5 µg/L in October 2020 following the June-July 2020 injection activities. TCE concentrations in SSC-6C (Figure 42) decreased following the 2011 fire and then generally stabilized at concentrations around 4,000 µg/L. TCE concentrations in the Waterloo well intervals monitoring the SBR are significantly lower than the concentrations observed in the overlying UFSB intervals and have decreased with depth. TCE was not detected in any of the Waterloo intervals within the SBR at SSC-3A. With regards to 1,4-dioxane it was only detected within the fenced area at REM-2 and SSC-6C. Based on the data collected to date, COCs within the SBR are limited to the area in the vicinity of the former SSC operations, with the exception of two detections of *c*-DCE at SSC-3A (255 ft bmp) near the laboratory reporting limit.

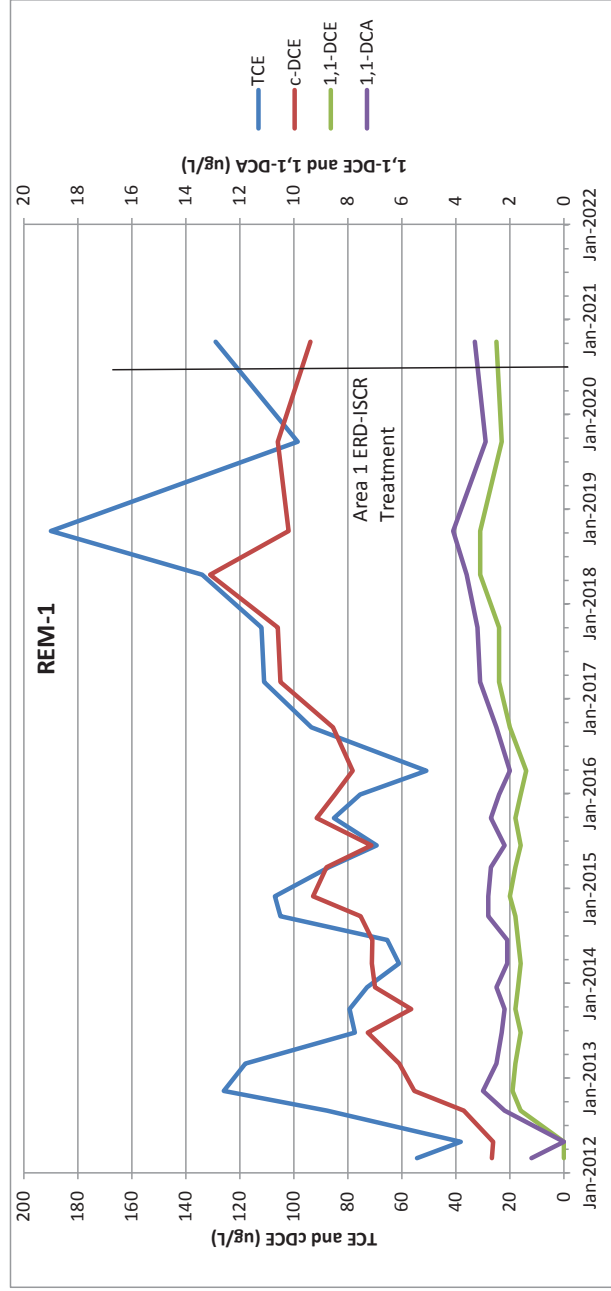
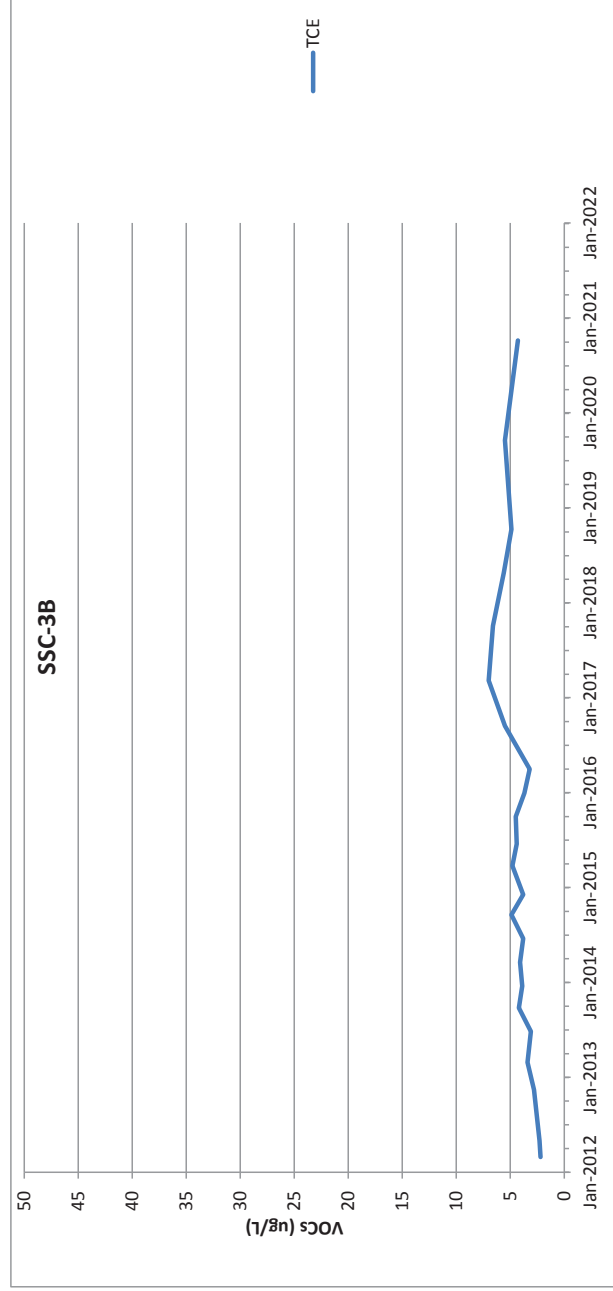
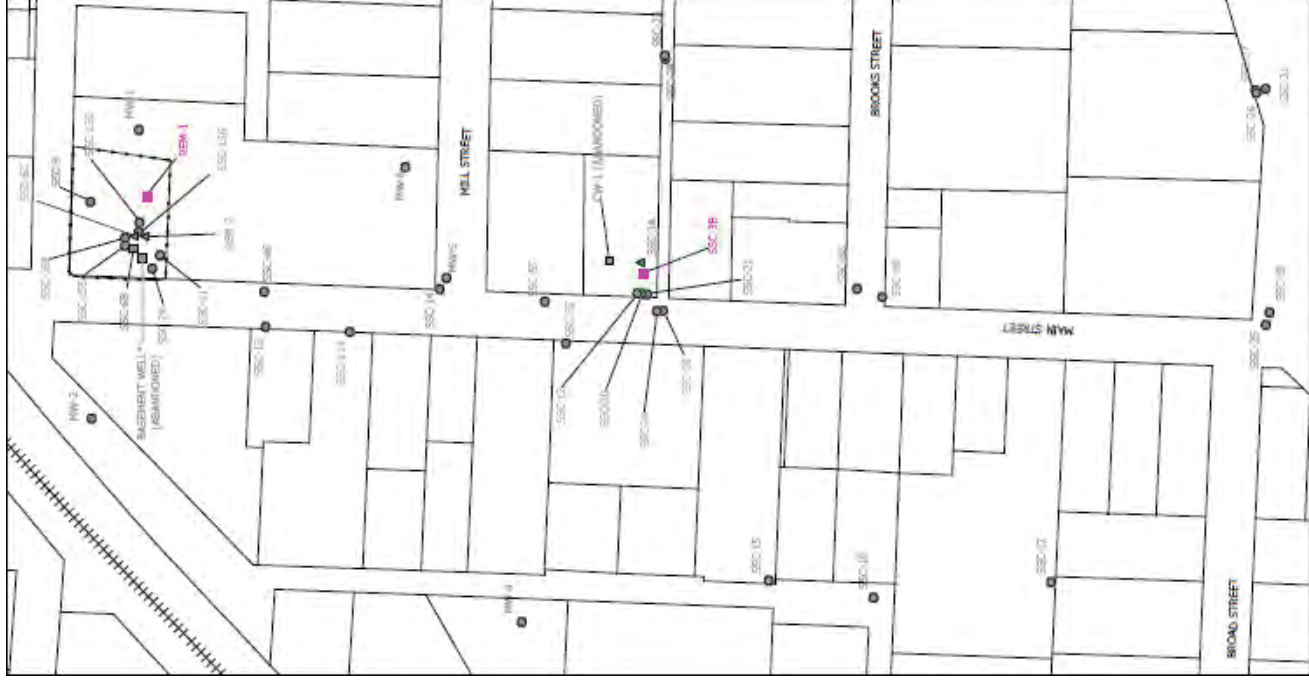
**FIGURE 43**  
**COC Concentrations in DBR Wells**  
**Solid State Circuits, Inc. Superfund Site**  
**Republic, Missouri**

Increases in COC concentrations were initially observed at REM-1 following pumping cessation but have stabilized near 5-7 µg/L (Figure 43). No other COCs have been detected at SSC-3B, including 1,4-dioxane. No other VOCs have been detected in the DBR sentinel monitoring wells. Two new DBR wells will be installed as part of the FFS scope, to provide further confidence in delineation of COCs in the DBR.

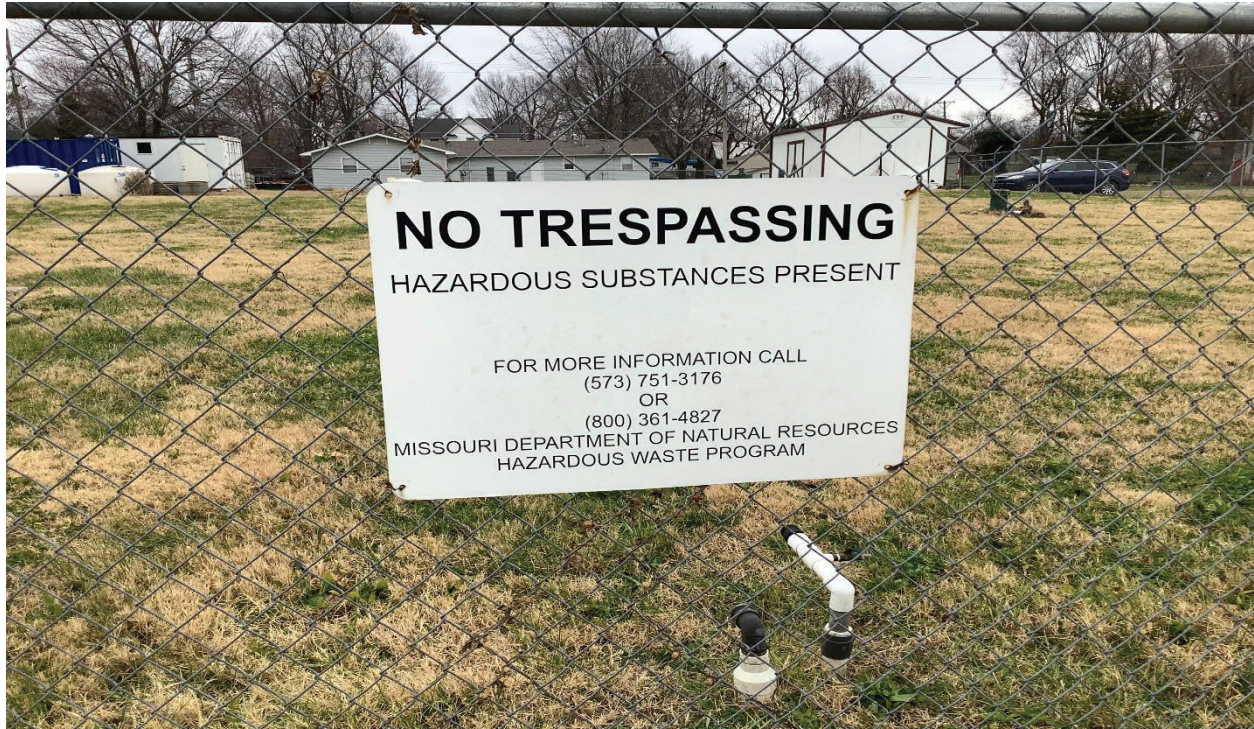
Photo 1. Site Signage on west fence.

Overall, the site inspection showed that the site is in a good state of repair and is being adequately maintained. The site inspection identified a sign missing on the north side of the fenced area of the site. The RP will replace the missing sign. The site inspection showed that the southern parcel of land was being used as a staging area for dumpsters and equipment related to utility line repairs, and that a former daycare facility north of the site is being renovated into a dog kennel.

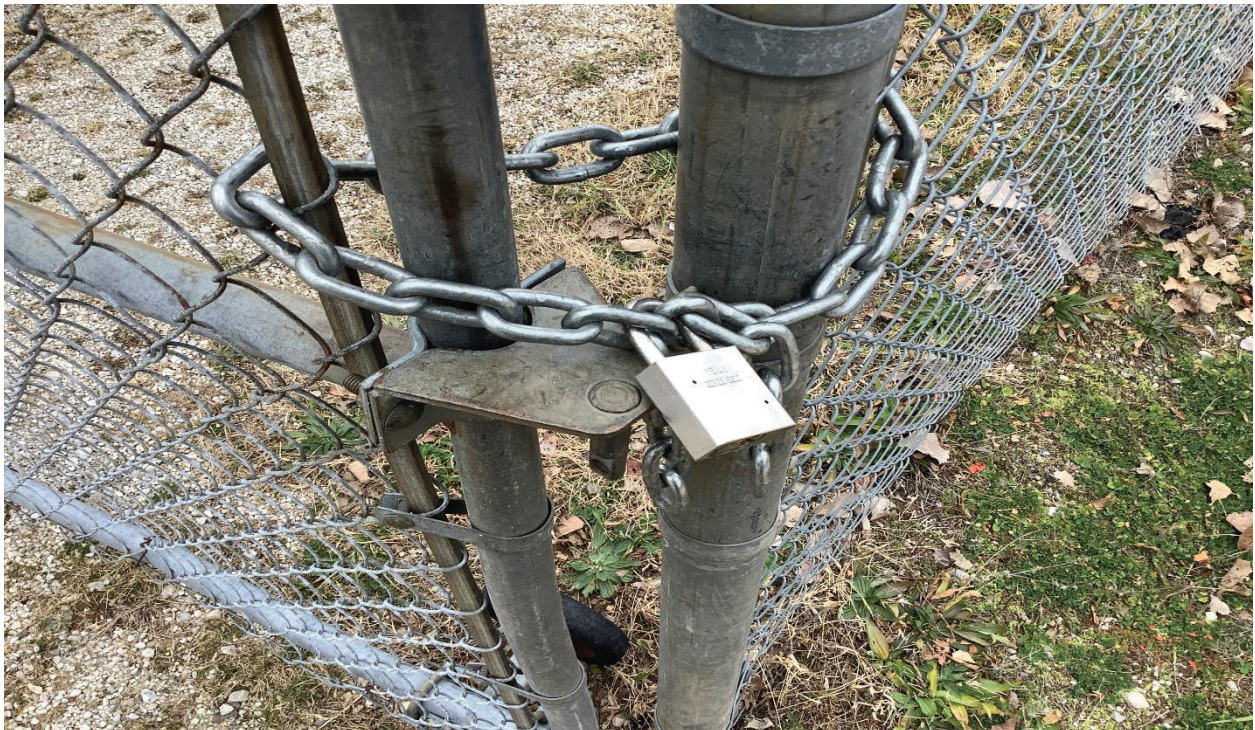
Photo 5. Fenced area secured by lock.

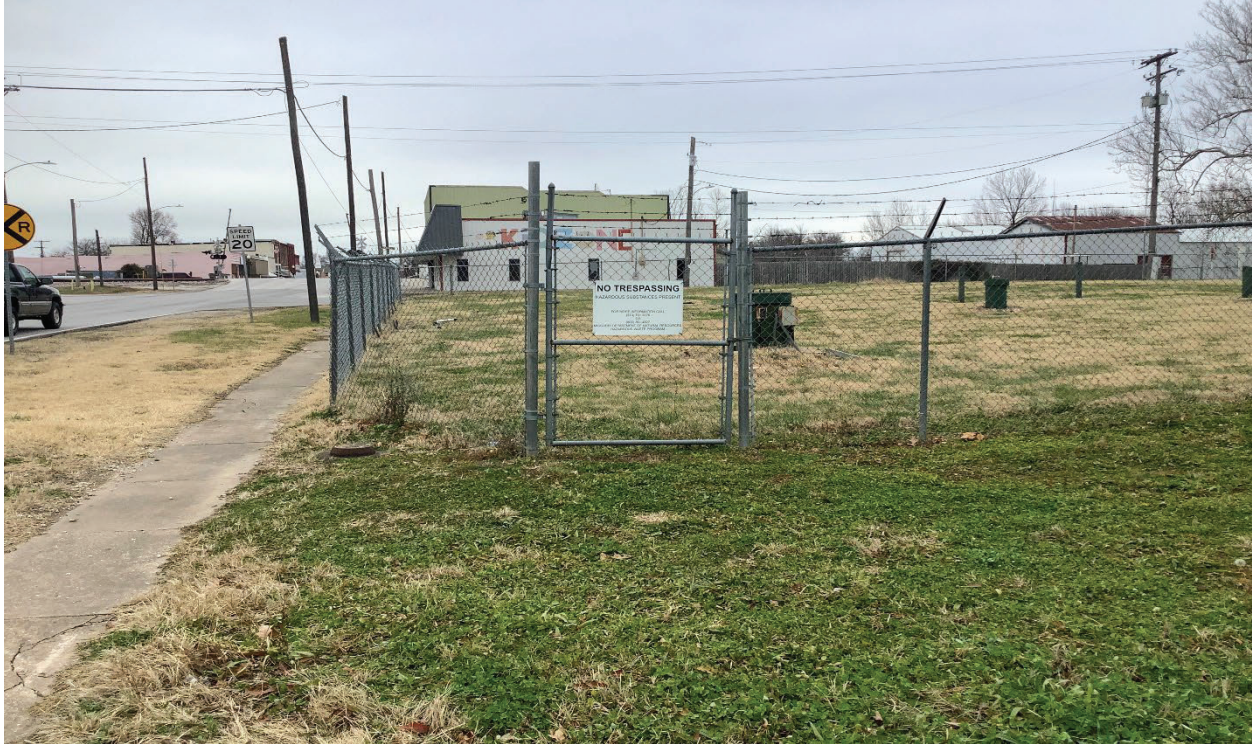
Photo 8. Looking north at the east side of the fenced in area.
